Manhole Inspection Summary

Manhole # S43EE_048MH

Location Address: **1711 e.chase st**

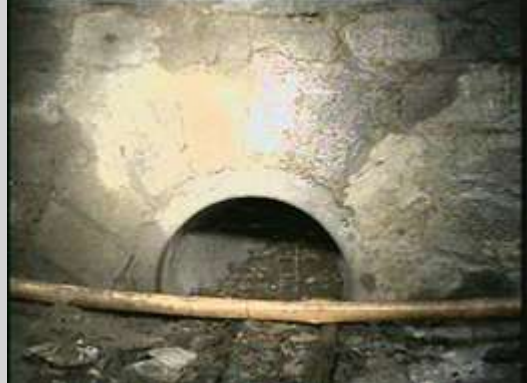
12 O'Clock Outflow

8 in. Circular Gravity Sewer
Pipe Out @ 12 O'Clock

Pipe Material: **Clay** ☐ Pipe Lined

Deposits: ☒ None ☐ Mud ☐ Sludge ☐ Debris ☐ Grease

Infiltration: **None** Pipe Seal Cond: **Unknown**
